Addendum to the Response Action Work Plan Former Stimson Central Maintenance Building Removal Plan 875 Highway 2 South

1.0 Introduction

This removal work plan is an addendum to the Response Action Work Plan (RAWP) (CDM 2003) and details specific information regarding removal activities that will take place at the Former Stimson Lumber Central Maintenance building, 875 Highway 2 South.

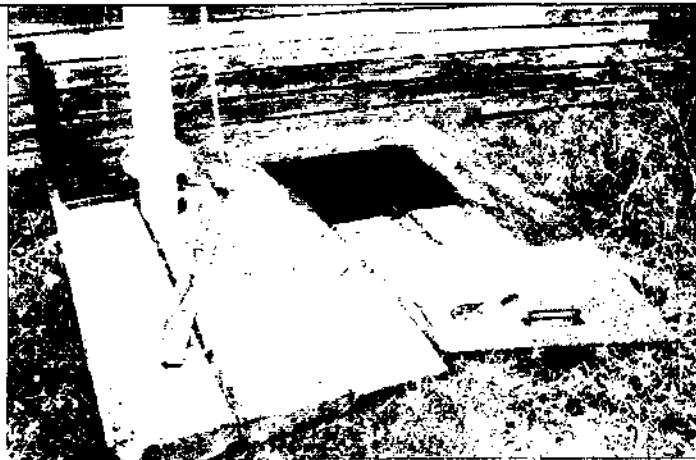
- The vault on the southeast corner of building has vermiculite in the soil floor. However, soil samples reveal that LA asbestos is non-detect. Therefore, no remediation will be required to the soil floor of the vault.
- Any remnant VCI located on the surface of the soil floor will be vacuumed.

Entrance to vault on the south east corner of the building. The Vault has creosote timber walls and a soil floor.

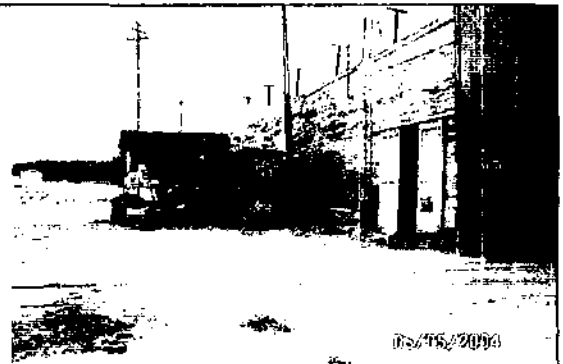
East side of Building, note the shed/shelves and pipe rack against the wall – the shed has no floor.
